**SHELLEY RIVERBANK EROSION PROTECTION –
ENGINEERING SERVICES**

ADDENDUM NO. 3

**Emergency River Bank Stabilization
Shelley, BC**

Summary Report

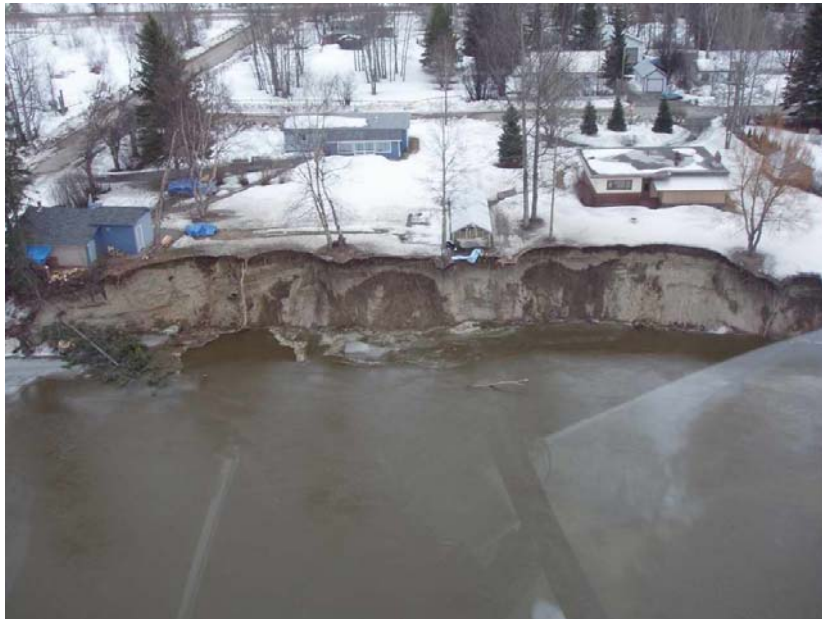
Figure 1 – Eroded Bank in Late March, 2007

Shelley is a small residential community located on the left bank of the Fraser River approximately 10 km northeast of the city of Prince George, BC. In January, 2007, unusual ice accumulation in the Fraser River resulted in a shift of its thalweg, directing high flow rates against the left bank. The unusual flow eroded the river bank resulting in the loss of 5 to 8 m (horizontal measurement) of property affecting two residences and leaving unstable, near vertical banks extending approximately 85 m along the affected property.

The eroded banks undermined two out-buildings and several trees as shown in the photo above. In March, 2007, the Fraser Basin Council received \$240,000 in emergency funding to mitigate the erosion. An inter-agency meeting took place on March 29, 2007 and was attended by representatives of the Fraser Basin Council, Regional district of Fraser-Fort George, BC Ministry of Environment, BC Ministry of Transportation, the Shelley Residents' Committee and McElhanney Consulting Services Ltd. No representatives of the federal Department of Fisheries and Oceans were available to attend the meeting.

Availability of funding was contingent on works being completed before May 15, 2007, leaving a limited time window for design and construction. The construction component was therefore sole-sourced to the contractor having a gravel pit closest to the community and the work proceeded on a time and materials basis using provincial "blue book" rates for equipment.

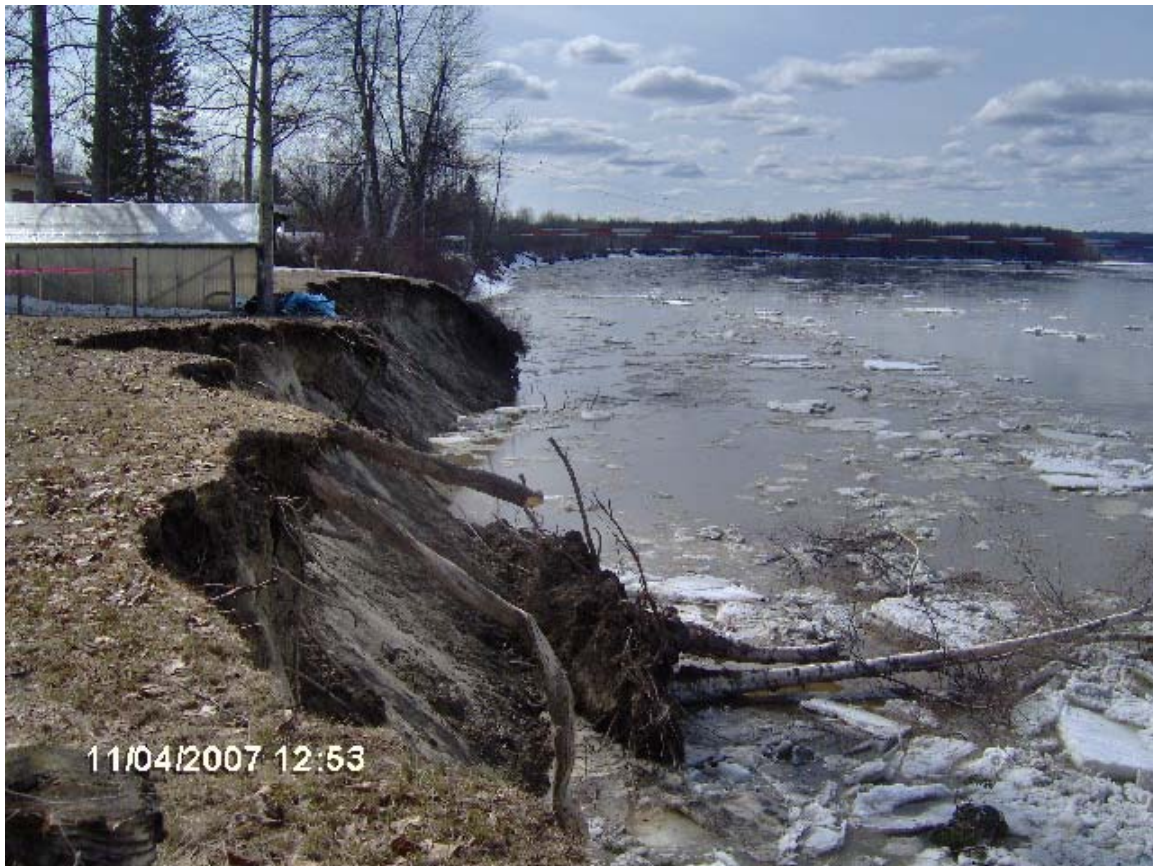
Figure 2 – Eroded Bank Prior to Stabilization Work

The photo above shows the condition of the bank at the beginning of the construction and the photo on the next page shows the completed dyke. Several existing trees had toppled into the Fraser River as a result of being undermined by the erosion on the bank.

The available funding was not sufficient to permit full mitigation of the slope with riprap and the construction was therefore limited to the installation of a riprap dyke along the foot of the eroded slope and trimming along the top of the bank. The top of the dyke was constructed to the approximate mean annual flood level which was approximately 1 to 2 m below the top of the existing bank. This component of the work was completed over the period from April 10 to April 16, 2007. A permit for the works under the BC Water Act was issued on April 12, 2007.

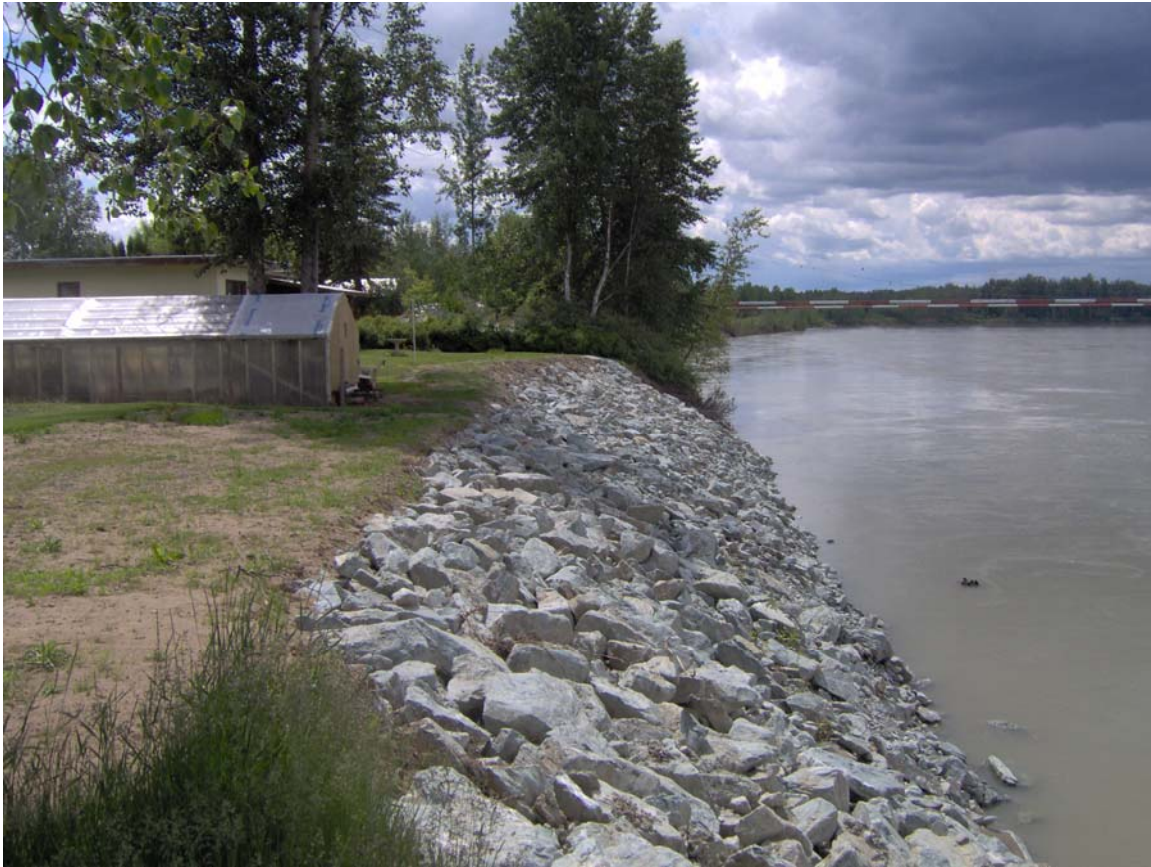
Figure 4 – Stabilized Bank at Shelley

Figure 4 is a photo of the finished bank stabilization in late June, 2007. Vegetation is getting reestablished on the top of the bank and the live poles are beginning to bud.

In mid-April, the Fraser Basin Council received an additional \$100,000 in funding to apply to the stabilization project. The additional funding permitted the installation of riprap to the full height of the slope, seeding along the top of the bank, and the installation of two groins and live pole plantings to address concerns expressed by DFO.
