## **PROPONENT ACTION PLAN FOR SHELLEY TOWNSITE BANK STABILIZATION**

### **Need for the Project:**

## MEMORANDUM

**Re:** Compensation/Monitoring Plan for Works along Shelley Townsite Riverbank

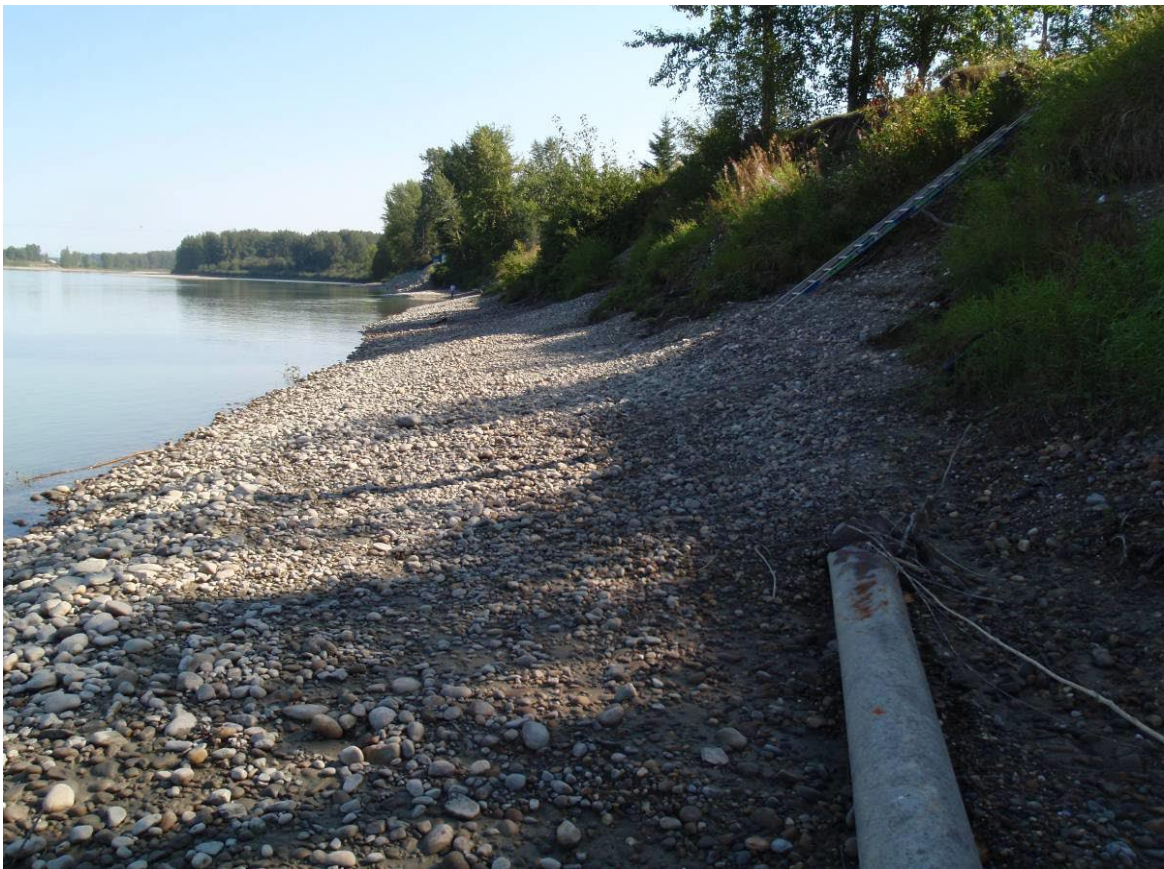
**Plate 1.** Upstream view from mid-project location showing the habitat conditions on August 31, 2009.

The channel margin at this site contains sand, gravels, and cobbles (Plates 1 to 4). At low winter flows the footprint area of the revetment is expected to be dry or, if wetted, the water would be so shallow it would typically freeze to the bottom. At higher water levels, this area provides minimal cover due to the lack of boulders, large woody debris or undercut banks. The channel margin habitat may be utilized by sculpins and juvenile salmonid species but this type of habitat is not limiting along this section of river.

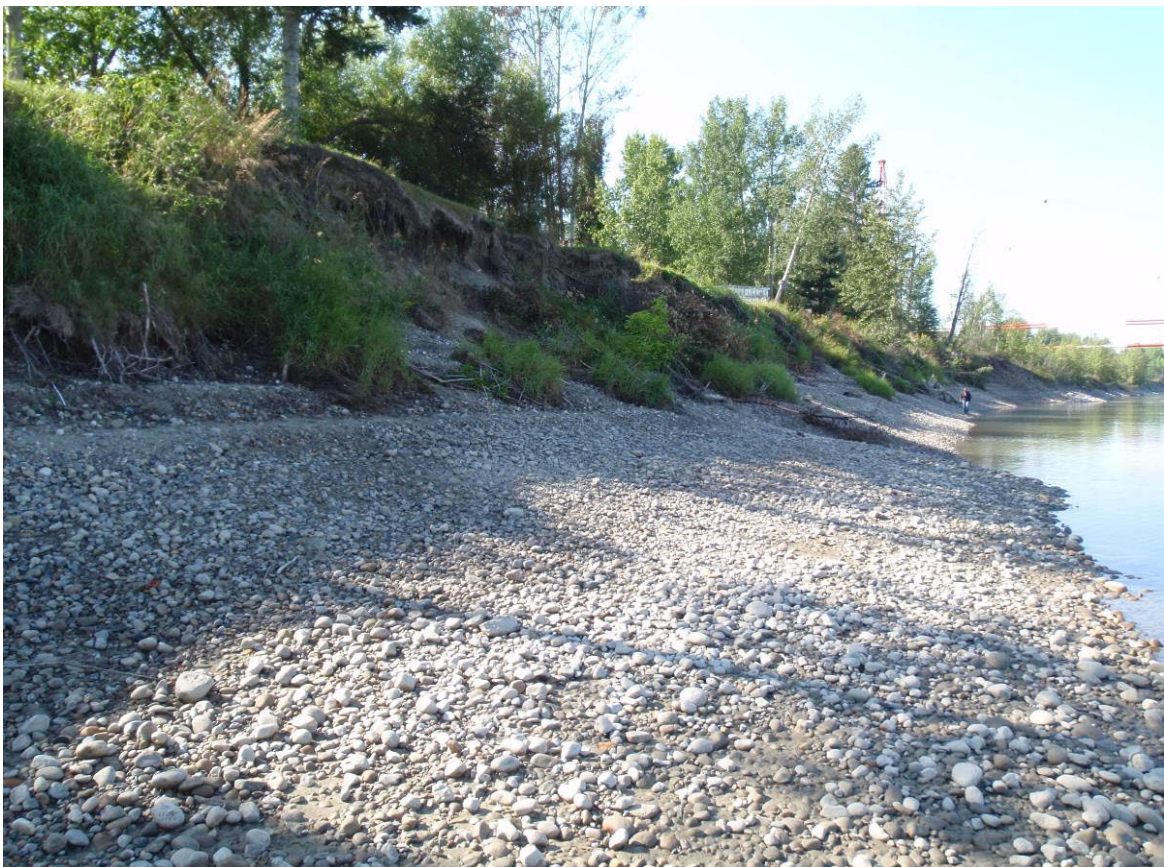
**Plate 2.** Downstream view from mid-project location showing the habitat conditions on August 31, 2009.

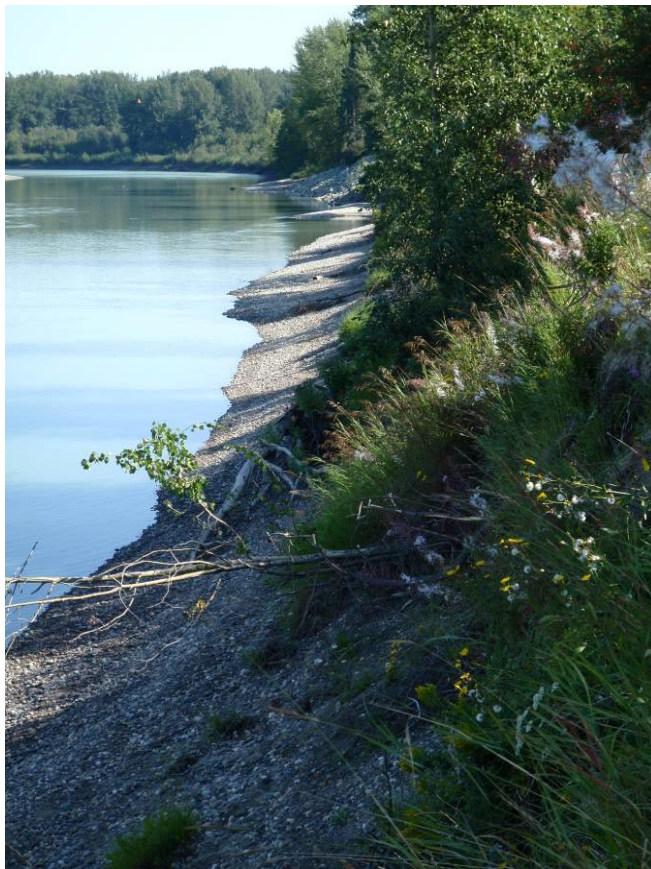
**Plate 3.** Upstream overview of the project area from the downstream end on August 31, 2009.

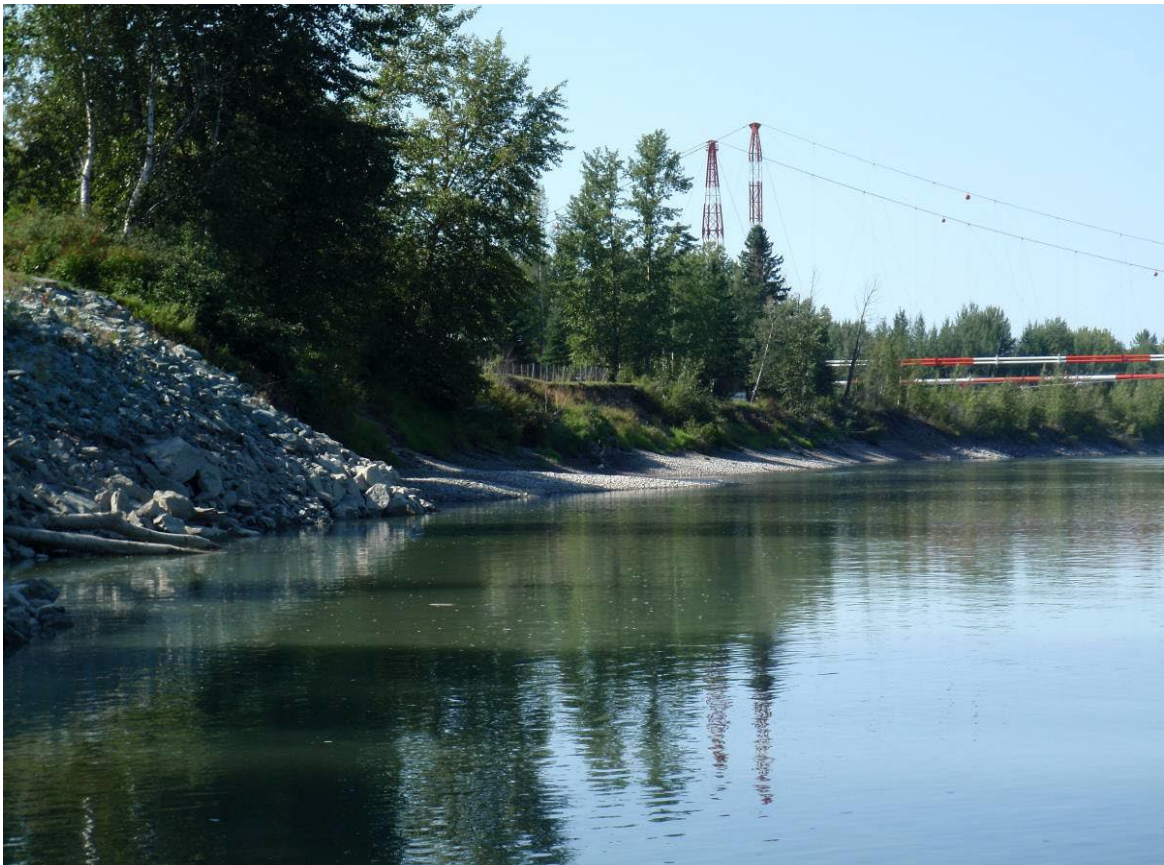
**Plate 4.** Downstream overview of the project area from the upstream end on August 31, 2009.

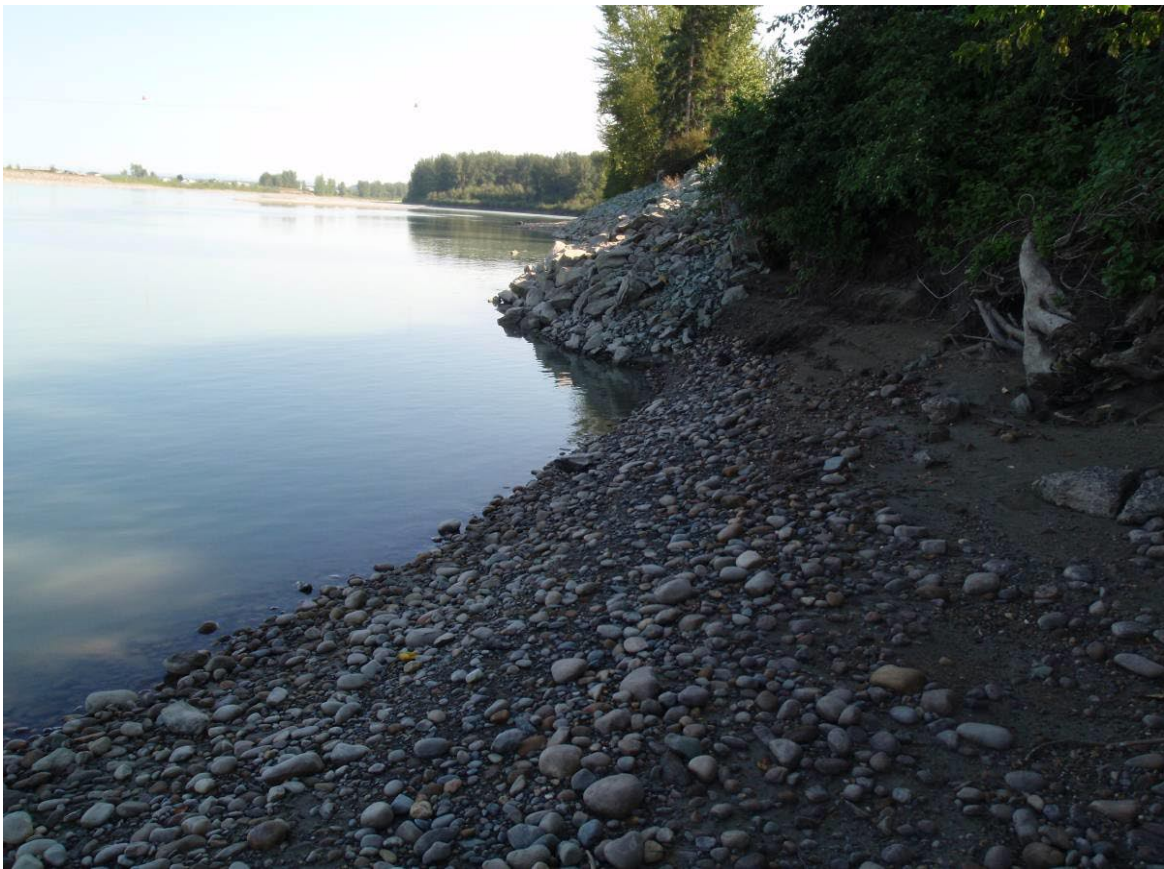
**Plate 5.** Upstream view showing the tie in point with the 2007 revetment project.

Construction is expected to progress from upstream to downstream. At the upstream end, it will be important to tie in to the existing revetment that was placed in 2007 (Plate 5). This will include filter cloth overlay, and may require some redistribution of the existing material. Prior to placing the rock, existing materials such as snow, ice, fallen trees, loose stumps and roots will be removed to minimize the risk the revetment could unravel when these features melt or decay. A layer of geotextile will underlie the riprap. The engineer-specified rock mixture will include a significant proportion of large material with 50% over 800 mm and 15% over 1100 mm.

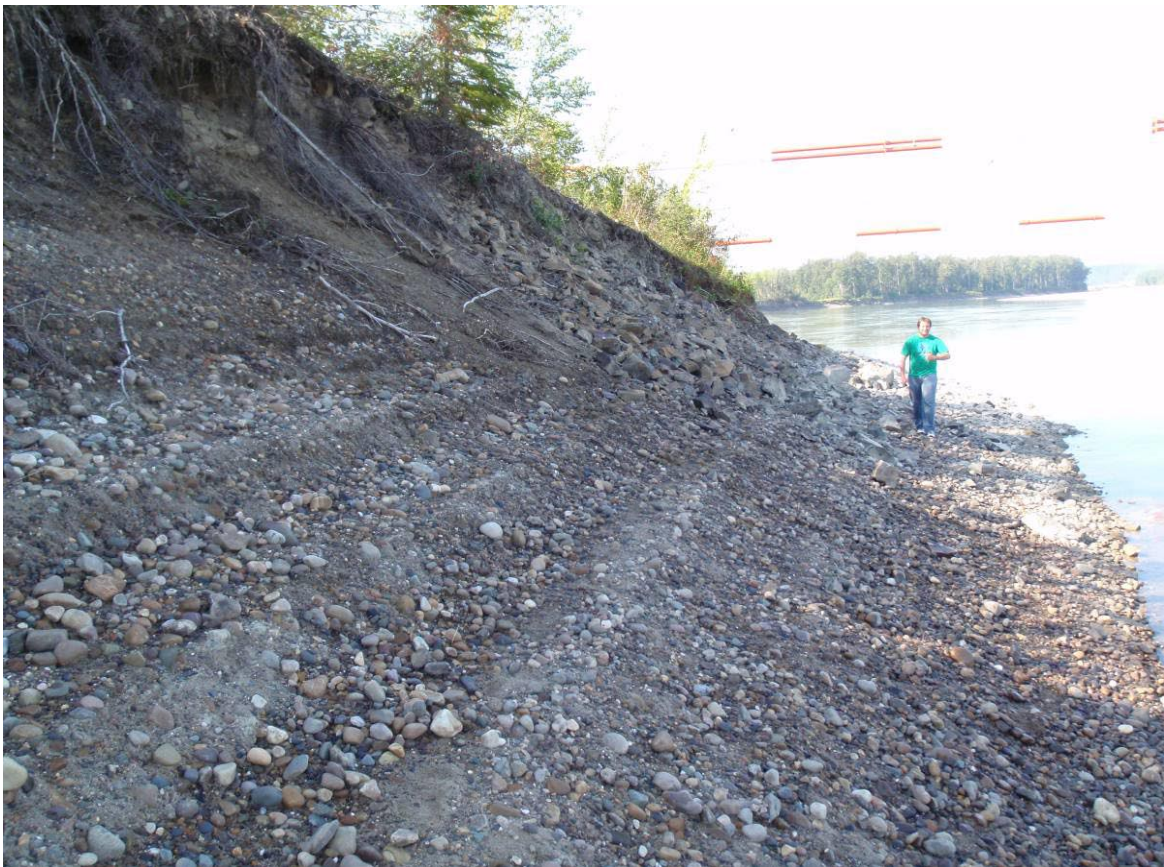
**Plate 6.** Downstream view showing remnants of previous riprap work within Spectra's ROW.

At the downstream end, the revetment will be keyed into the bank at the edge of Spectra's right-of-way (ROW), approximately 25 m upstream of where some previous armouring had been done (Plate 6). Since this previous rock work is now unravelling and offers minimal protection to the bank, the design objective for the downstream end of the new revetment is to blend into the bank to minimize downstream effects to Spectra's ROW.
